Manhole Inspection Summary

Manhole # S31WW1021MH

Insp Date: **1/16/07 1:02 PM**

Location Address: **5109 SAINT ALBANS WAY**

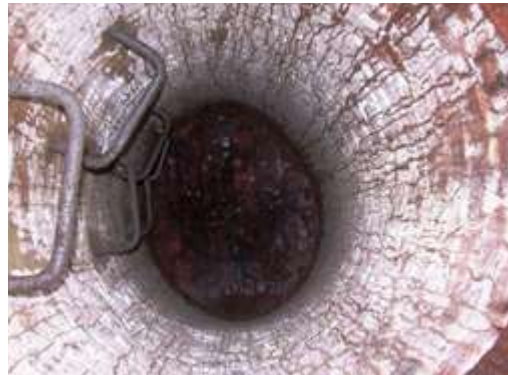
Top View

Channel debris.

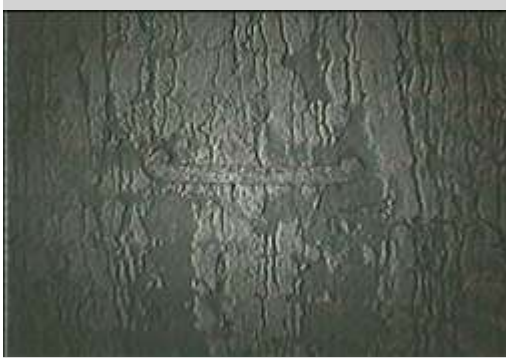
Defect

Corbel infiltration.

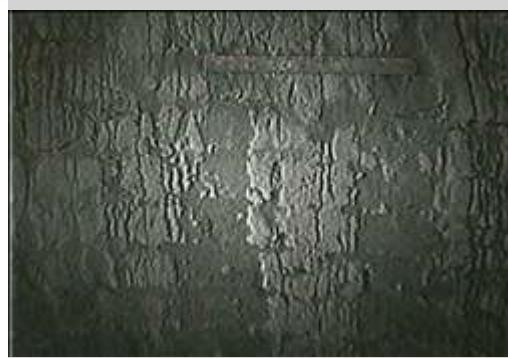
Defect

Barrel infiltration.

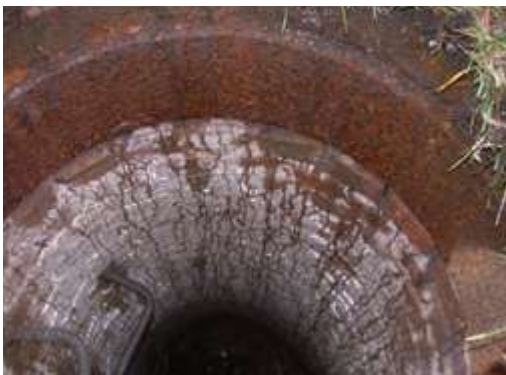
Defect

Frame leaks. Adjustment infiltration - other side.

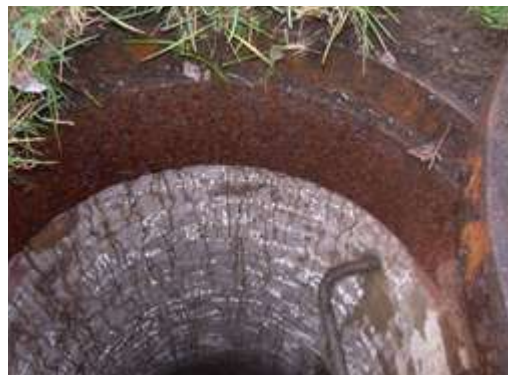
Defect

Frame leaks. Adjustment infiltration.

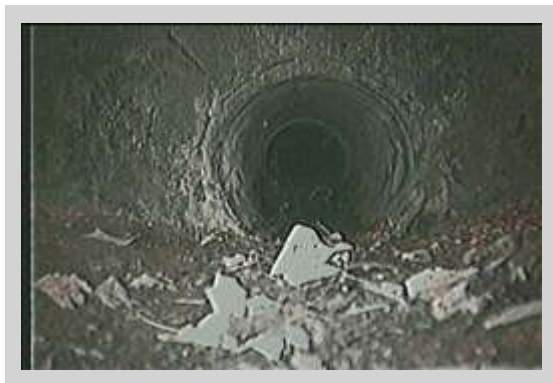
Pipe Out @ 12 O'Clock

Pipe Seal Cond: **Cracked**
